Manhole Inspection Summary

Manhole # S07OO1007MH

Location Address: **3327 SPAULDING AVE** Cross Street: **DENMORE AVE**

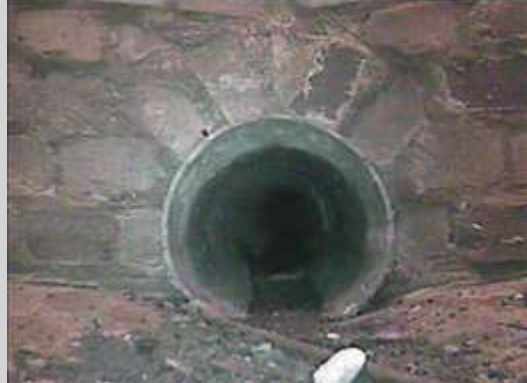
12 O'Clock Outflow

8 in. Circular Gravity Sewer
Pipe Out @ 12 O'Clock

Pipe Material: **PVC** ☒ Pipe Lined

Infiltration: **None** Pipe Seal Cond: **Sound**
